CHAPTER D-7 FOUNDATION RISKS FOR CONCRETE DAMS

D-7.1 Key Concepts

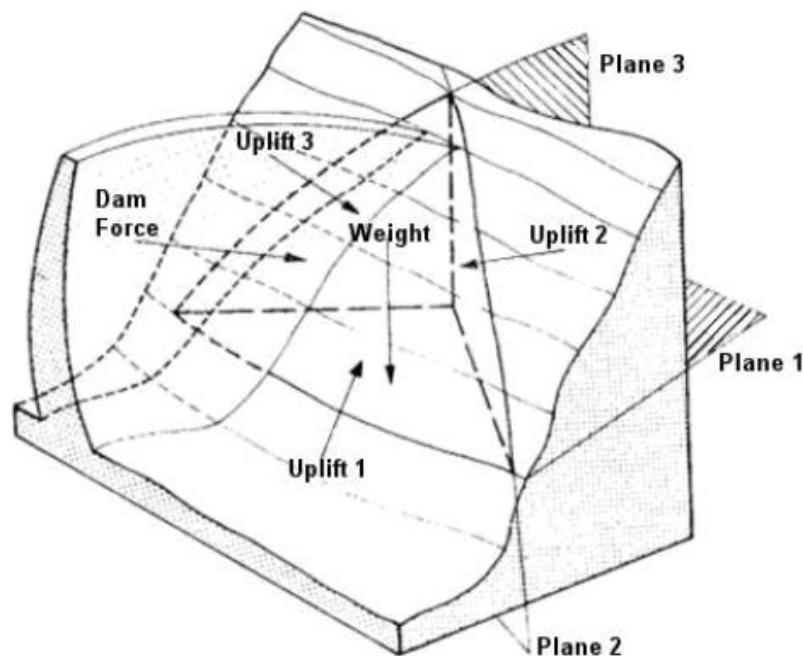
Perhaps the most critical area for evaluating the foundation of a concrete dam has to do with sliding along geologic discontinuities within the abutment or foundation of a dam. Planes or intersections of planes that daylight downstream and form wedges upon which the dam rests should be identified and evaluated for sliding stability. Figure D-7-1 shows schematically how such a wedge might form, and the forces acting on such a wedge. In this case it is likely the wedge would tend to slide along the intersection of Plane 1 and Plane 2 under the applied loads.

Figure D-7-1 Example of Potentially Unstable Foundation Wedge (adapted from Londe, 1973)

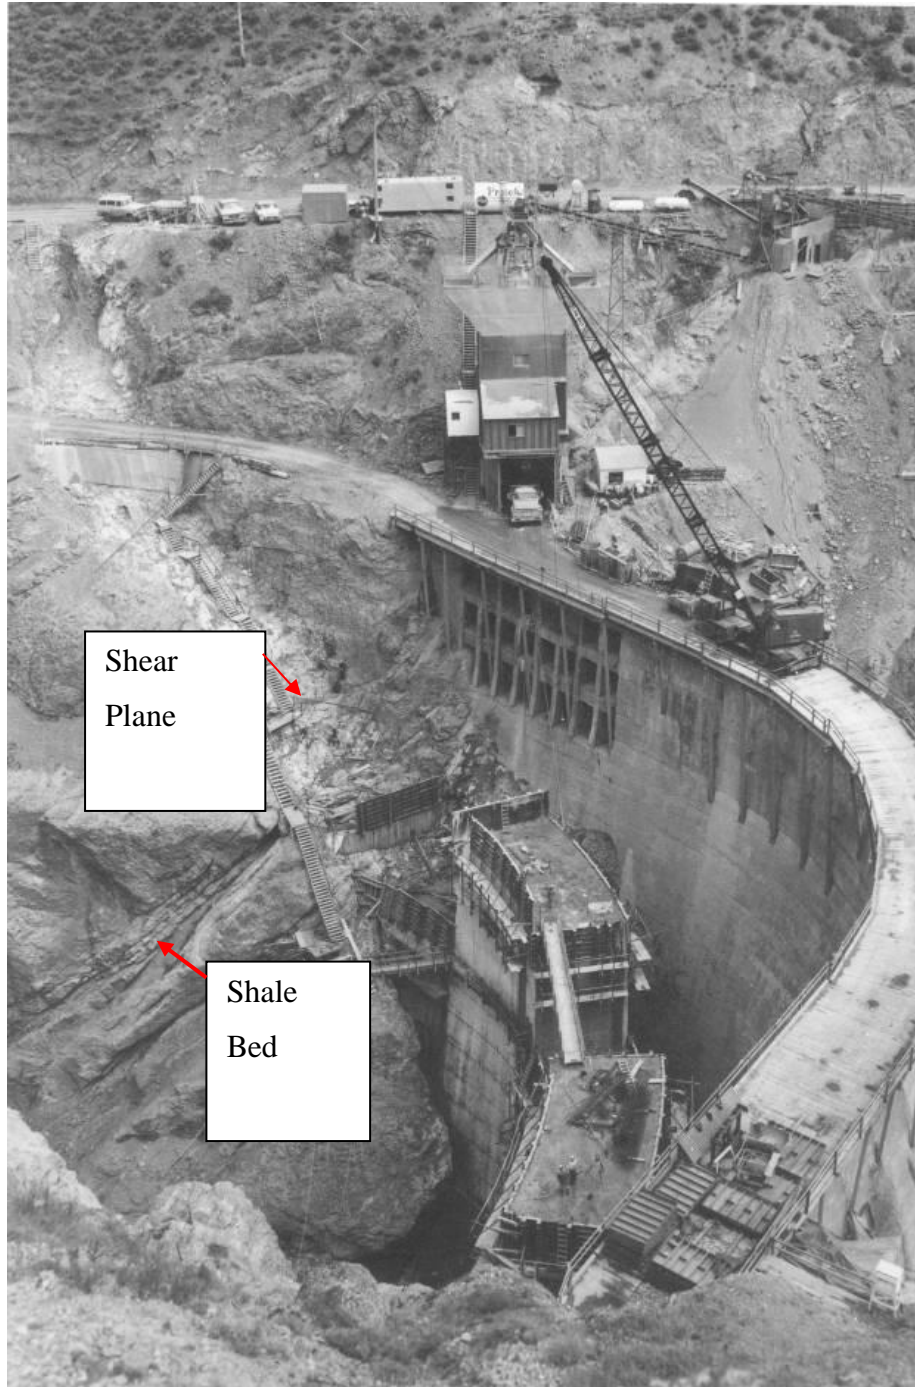
Figure D-7-2 Construction Photo Showing Major Discontinuities (note new arch dam being constructed immediately downstream of an existing arch dam)

One step in identifying potentially unstable foundation wedges requires carefully searching available foundation maps, construction photographs, drill hole data, LiDAR analysis, and/or lineation mapping for characterizing discontinuities important to stability, particularly continuous low angle base planes that may daylight (i.e. intersect with the downstream topography in a manner that allows movement) downstream along with continuous side planes. The search should continue downstream of the foundation contact where discontinuities may be visible or were mapped. In the past, it was common to map the foundation in detail; however the areas downstream of the abutments were not always exposed and were often unmapped. This is a very important area to investigate, looking for daylighting discontinuities that could influence stability. Critical low angle planes may not be visible in the foundation. Construction photographs can be invaluable in identifying discontinuities in this area, as well as in the excavation footprint, as shown in Figure D-7-2.

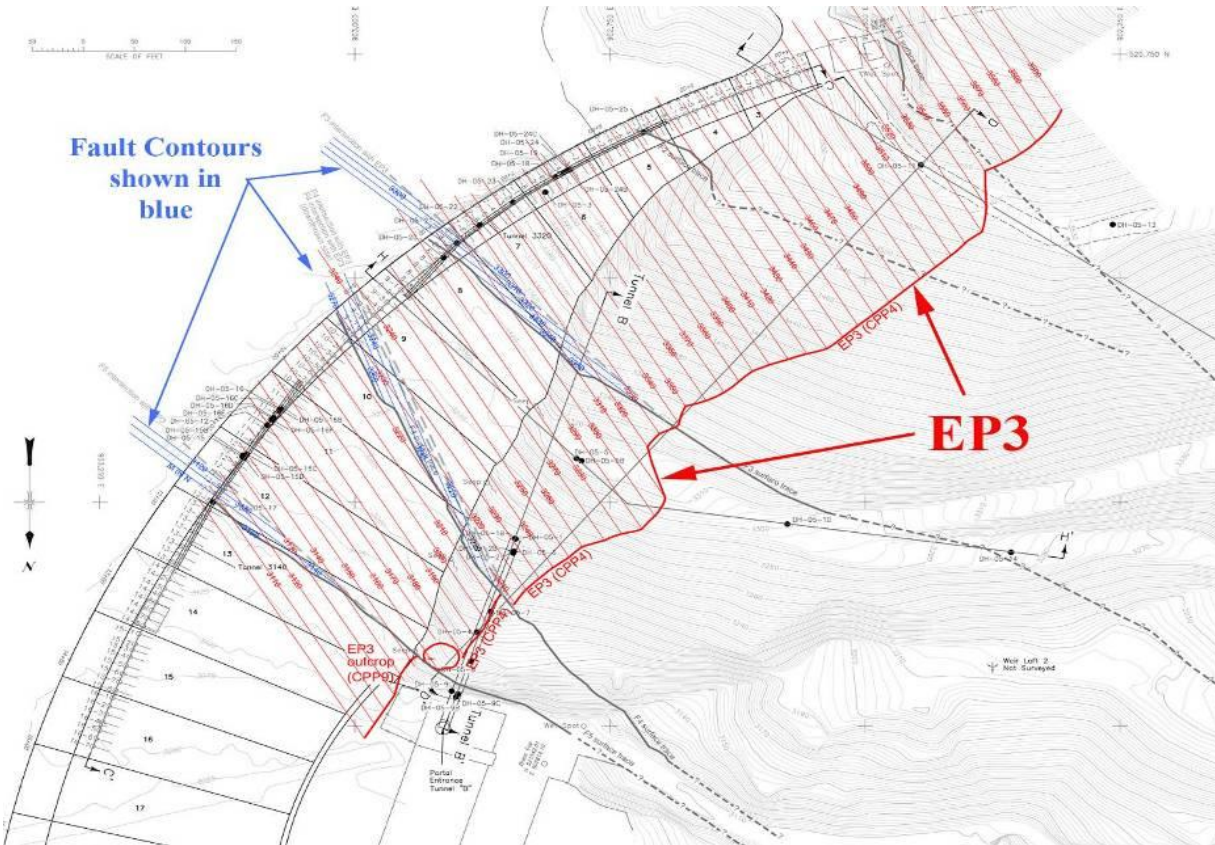
Major discontinuities that are continuous relative to the foundation dimensions and potentially weak in shear (or that can release in tension near the upstream wedge boundary) should be identified, and their location, orientation, and characteristics should be defined. It is important to portray the geologic information on plan maps, cross sections, profiles, and structural contour maps so that the geometry is well understood and appropriate evaluations and calculations can be made. Figure D-7-3 shows example structural contours on prominent clay-coated bedding plane partings and faults. For this project, a difference in several degrees of bedding strike had a large influence on calculated stability. Information from many different sources was combined to develop structural contours for each fault and prominent “EP (Engineering Plane) bedding plane”. These planes represented potential sliding surfaces that included multiple bedding planes that aligned across faults. Data available included: preconstruction exploration; construction mapping of the foundation and adits; construction photographs of the foundation; and post construction drilling and borehole geophysics performed in the existing drain holes. EP3 was identified as the critical potential slide plane based on its close proximity to the dam foundation contact, and its extent from fault 1 at the upstream end of the dam down to fault 4 towards the bottom of the abutment. EP3 daylights downstream along with its intersections with several faults on the abutment.

Figure D-7-3 Structural Contours on Major Discontinuities

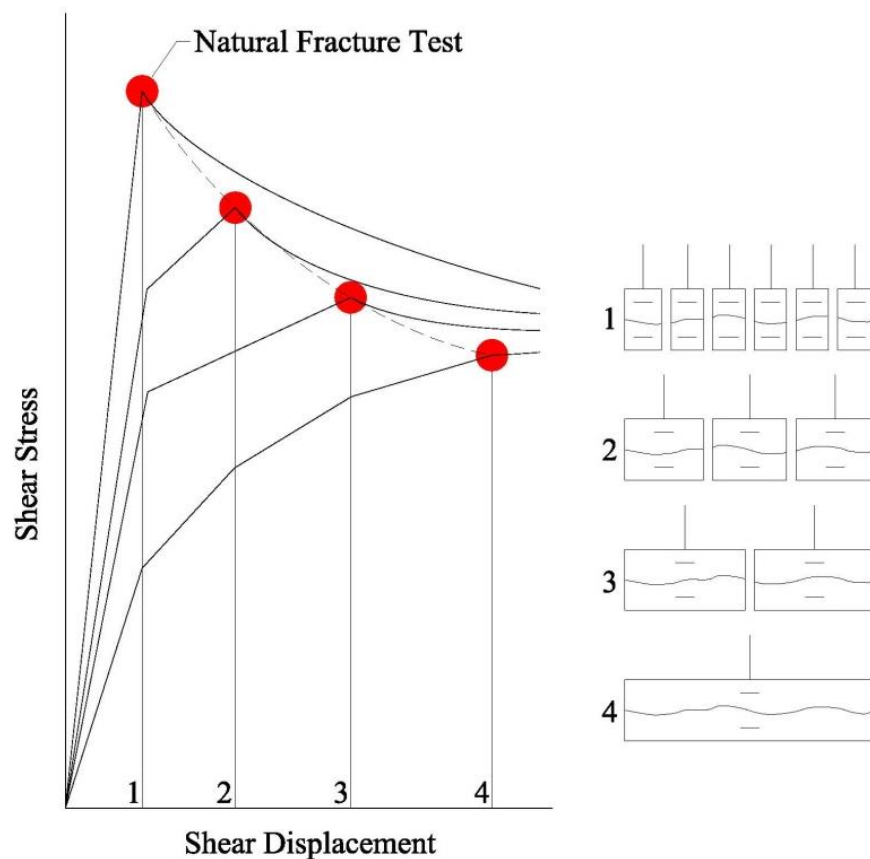
Bandis et al (1983) performed direct shear tests on samples of natural fractures as shown in Figure D-7-4. They started by testing a large specimen, then proceeded to cut it into smaller and smaller specimens. On average, the strengths increased as the specimens became smaller. This indicates that the small scale asperities are not mobilized when shearing large scale joints, and testing of small scale rough joint specimens can therefore overpredict the strength. Some have proposed testing saw cuts to overcome this issue and estimate a basic friction angle for a given rock type. However, this leads to more uncertainty as most saw blades can polish the surface

Figure D-7-4 Scale Effects from Testing Natural Joints (adapted from Bandis et al, 1983)

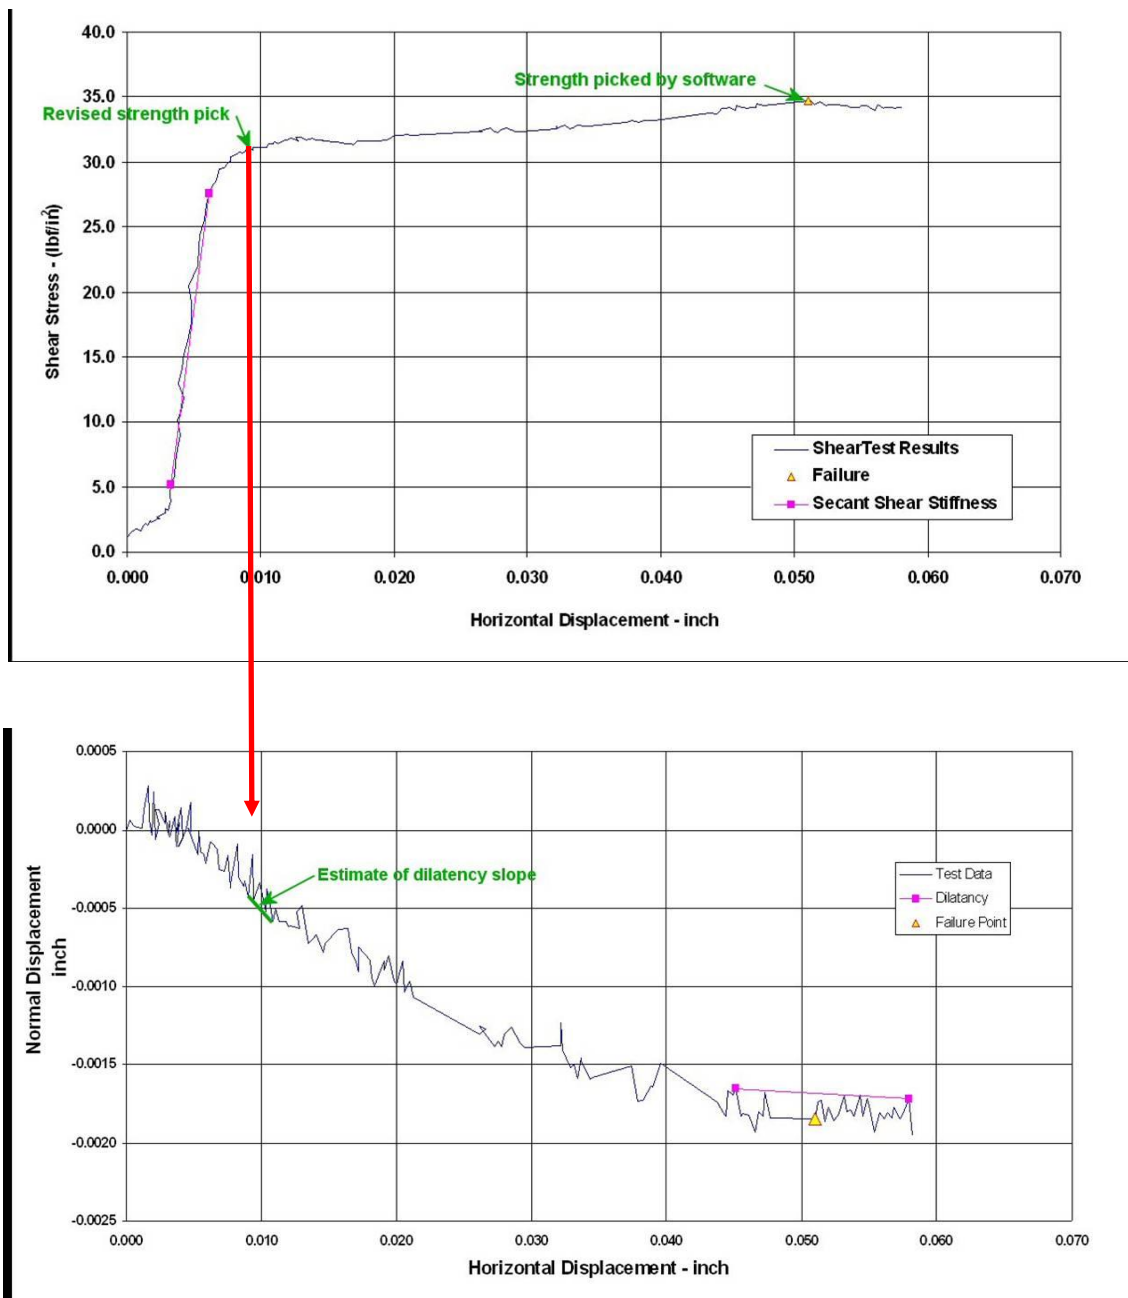
smoother than the individual rock grains leading to conservative estimates of the basic friction angle. Attempts to artificially roughen a saw cut surface can result in significant variation and uncertainty as well, and any alteration along the joint surfaces is not taken into account with such an approach. A better approach to determining the basic friction angle seems to include subtracting the specimen dilation by measuring the normal and shear displacement during testing. The slope of the normal displacement vs. shear displacement curve at the point of sliding is the dilatency angle. Figure D-7-5 shows the relevant plots from a direct shear test.

Figure D-7-5 Direct Shear Test Plots

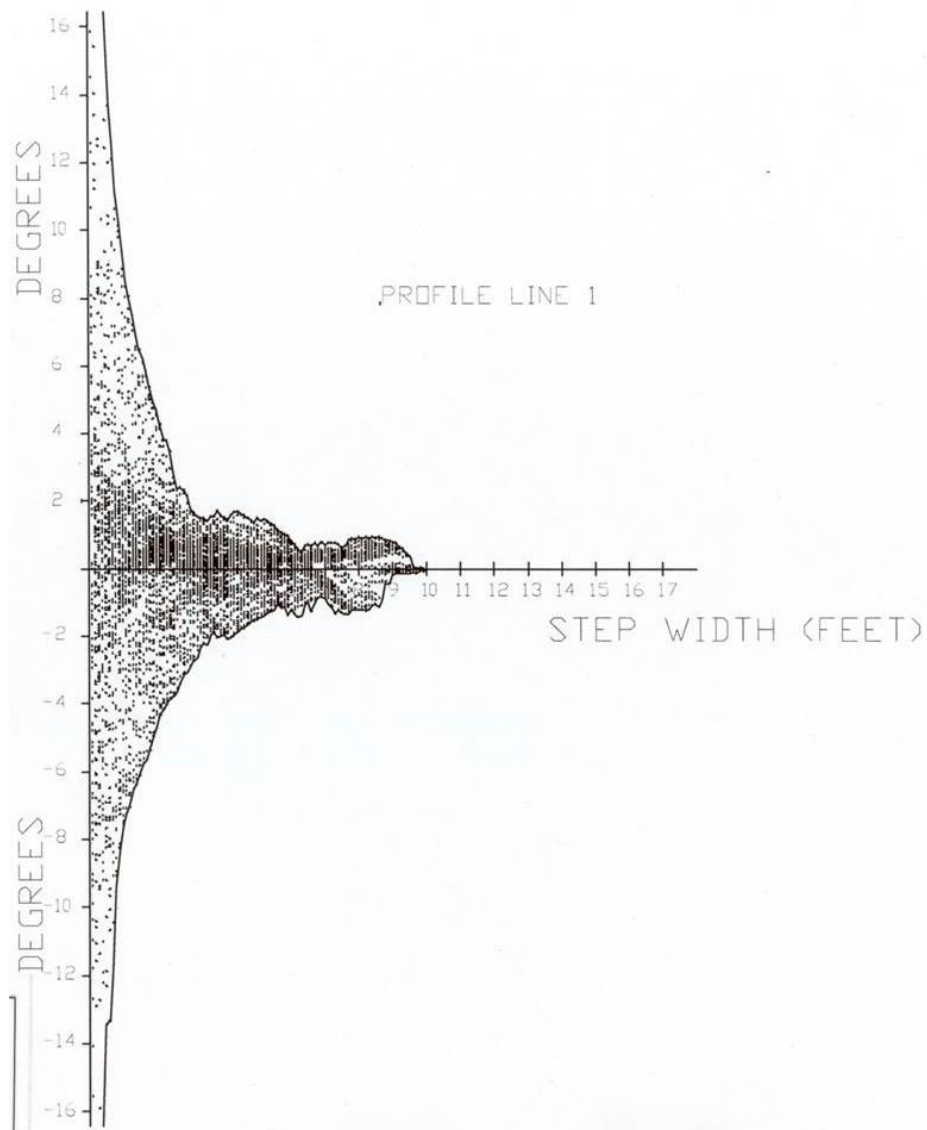
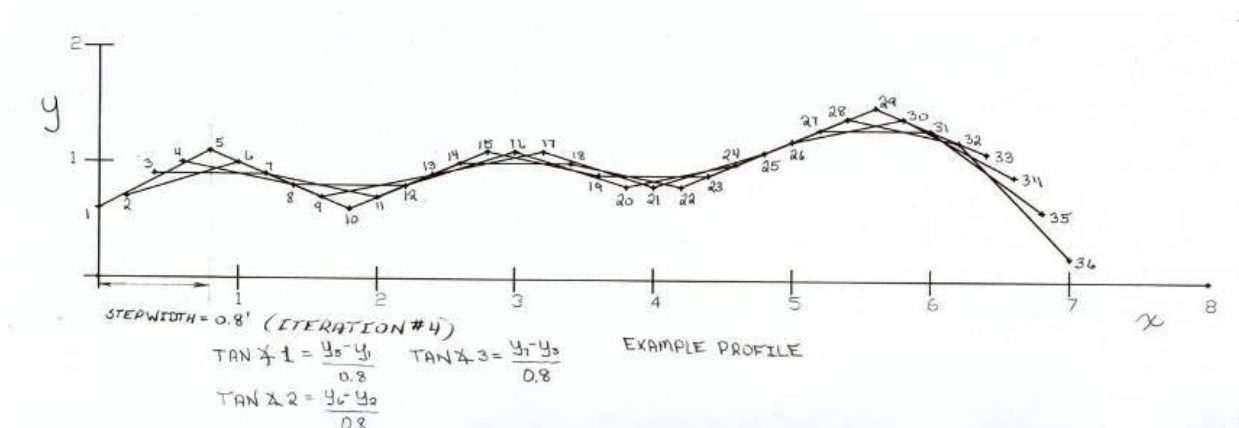
Figure D-7-6 Waviness Angle Analysis (after Rengers, 1970)

The scatter in the corrected data should be reduced over that obtained from the raw test data. Once a basic friction angle has been established, the large scale asperity angles or undulations can be added to obtain an estimate of effective in situ friction angle. This typically requires some field measurements. Photogrammetry models (see chapter on geological information needed for a risk analysis) of large discontinuity surfaces can be useful for making these measurements. Typically, angles are measured along a large scale discontinuity profile using increasing step width (constructed as consecutive segments along the profile). The asperity angles are plotted as a function of step width as shown in Figure D-7-6. The asperity angle may converge to a steady state value, or a value that corresponds to 1 to 2 percent of the in situ sliding plane length has sometimes been selected to represent the waviness angle to be added to the basic friction angle. For probabilistic analyses, ranges or distributions in both the basic friction angle and waviness angle should be considered.

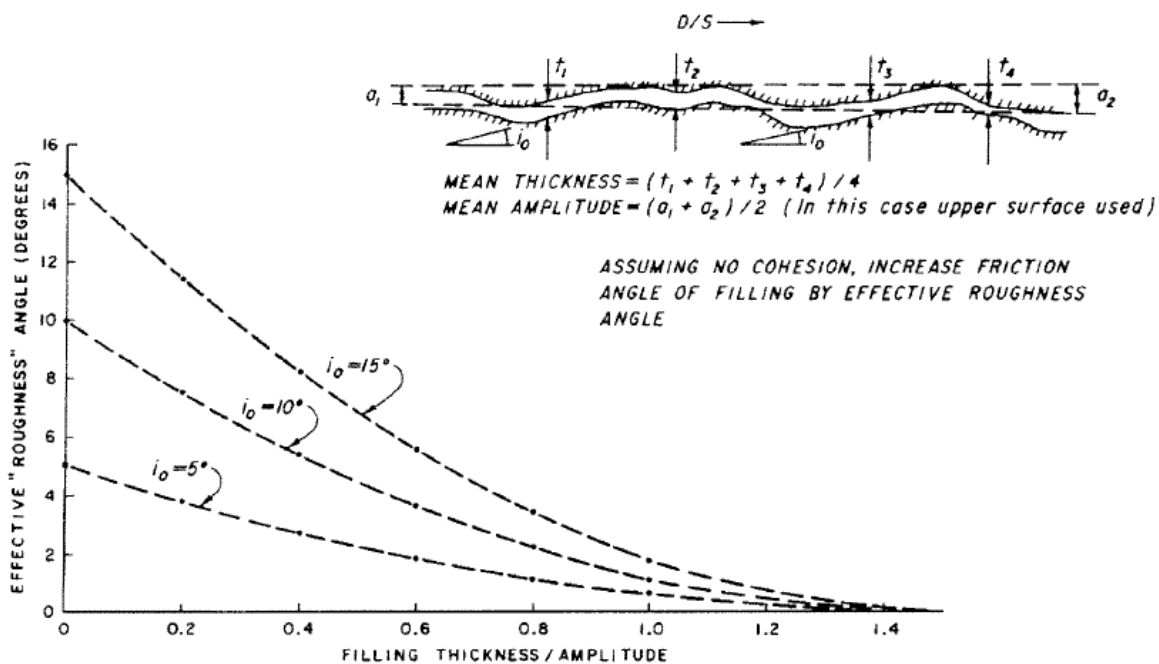
In some cases a critical sliding plane will be filled with softer infilling material, and the strength of the filling material will have a major effect on its shear strength. It can also affect the roughness or waviness component of the shear strength as the filling material compresses during shearing. To account for this, Ladanyi and Archambault (1977) have proposed some relationships that are plotted in Figure D-7-7. An effective roughness angle can be estimated based on the ratio of the Filling Thickness/Rock Wall Amplitude. Again, ranges or distributions should be considered when performing probabilistic analyses.

Figure D-7-7 Effective Waviness Angle for Filled Discontinuities (adapted from Ladanyi and Archambault, 1977)

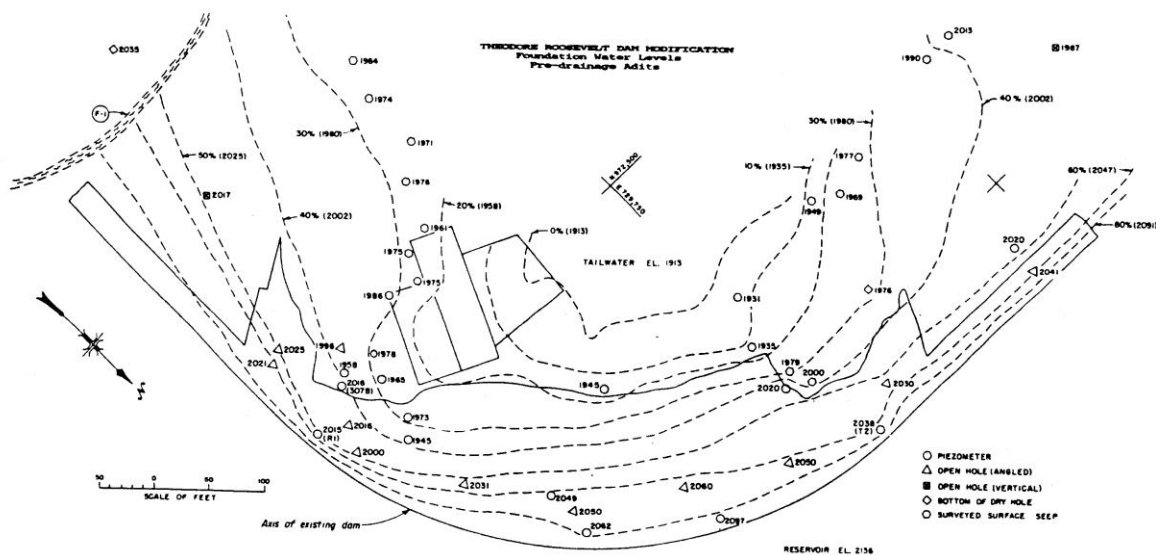
Despite the advancements in seepage modeling that are available, experience suggests that it is difficult to model flow through jointed rock and accurately predict foundation water pressures. Therefore, typically foundation pressures are measured at key points using piezometers installed in areas of water conduits. If enough piezometers are installed, water pressure contour maps can be generated as shown in Figure D-7-8.

Figure D-7-8 Foundation Water Pressure Contour Map

The water pressure contour map, and structural contour map of the foundation wedge planes can be used to estimate water pressures and total water force acting normal to the planes. Sufficient piezometer data may not be available, in which case interpretations of the groundwater contours and elevations may need to be predicted or inferred based on modeling or rules-of-thumb. The intersection of the phreatic surface with the wedge planes must be determined unless the wedge planes are fully submerged. Then, using the water pressure contours, the plane is divided into areas across which the variation in water pressure is generally uniform. The pressures at each corner of these areas are calculated by subtracting the elevation of the point on the plane from the elevation of the water pressure contour directly above it. The average pressure multiplied by the area gives a force, and the summation of all such forces gives a total force on the plane.

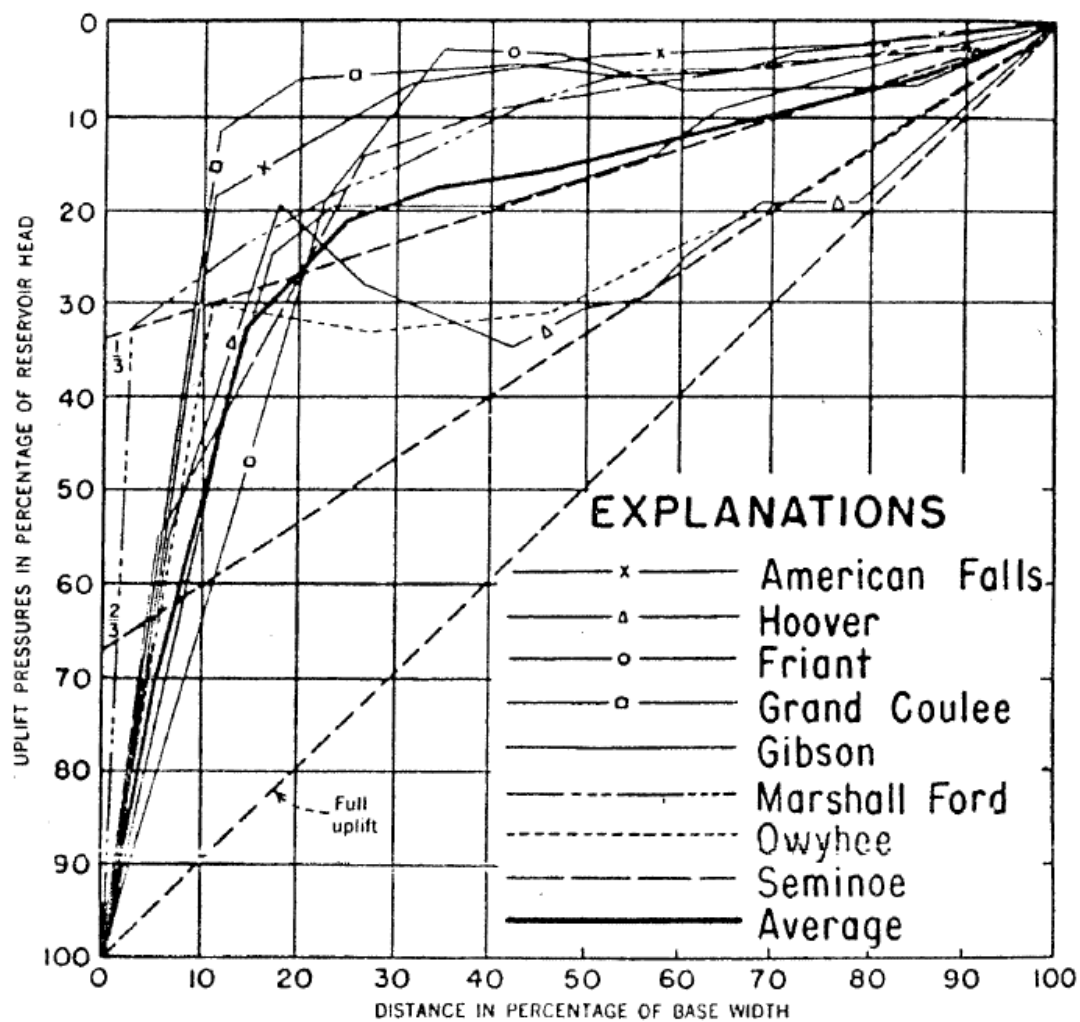
A line of drains is typically installed as a defensive measure in a concrete dam foundation. If functioning, the drains can dramatically reduce the foundation water pressures, which would be reflected in the water pressure contours. Measurements just below the foundation contact of several large concrete dams show that the pressures downstream of a line of functioning drains are greatly reduced by the drainage, as shown in Figure D-7-9. It can be noted that the original measurements made at Hoover Dam and Owyhee Dam did not show as much pressure reduction.

Figure D-7-9 Uplift Measurements at Concrete Dams

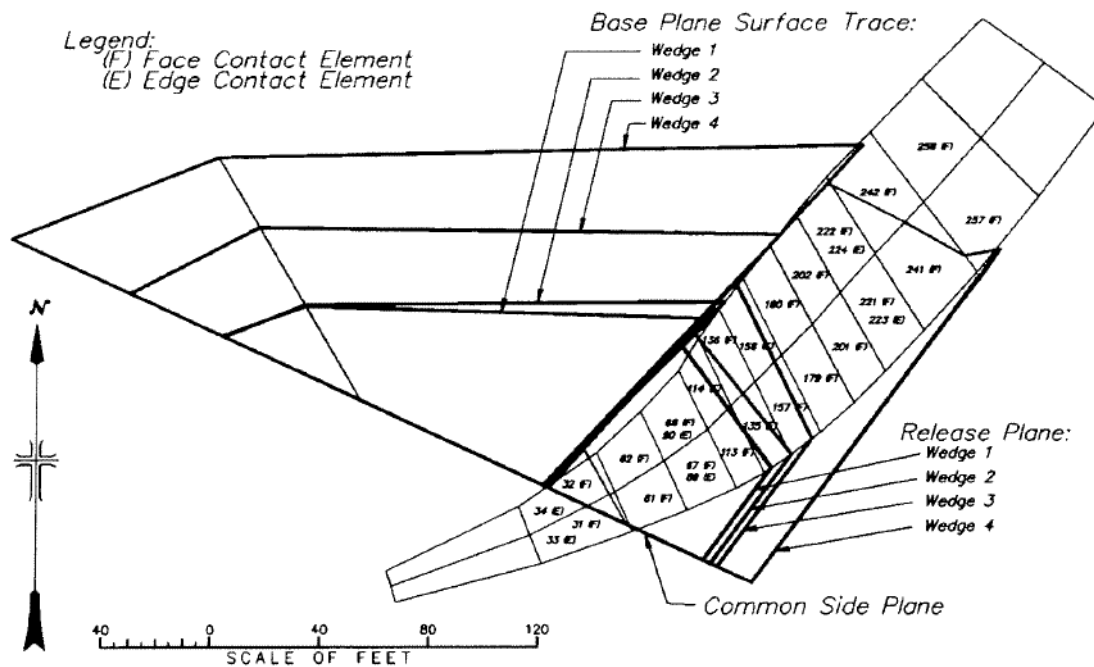
Loading from the dam is needed to complete a foundation stability analysis. Initially, uncoupled analyses are typically performed whereby external loading from the dam is calculated and applied to the foundation wedge in a rigid wedge limit equilibrium analysis. Finite element analyses are often used for such calculations, whereby the nodal forces from elements contacting the wedge, as shown in Figure D-7-10, are used to estimate the external loading. Forces can be time-varying for seismic analyses.

Figure D-7-10 Finite Element Mesh Superimposed on Nested Foundation Wedges

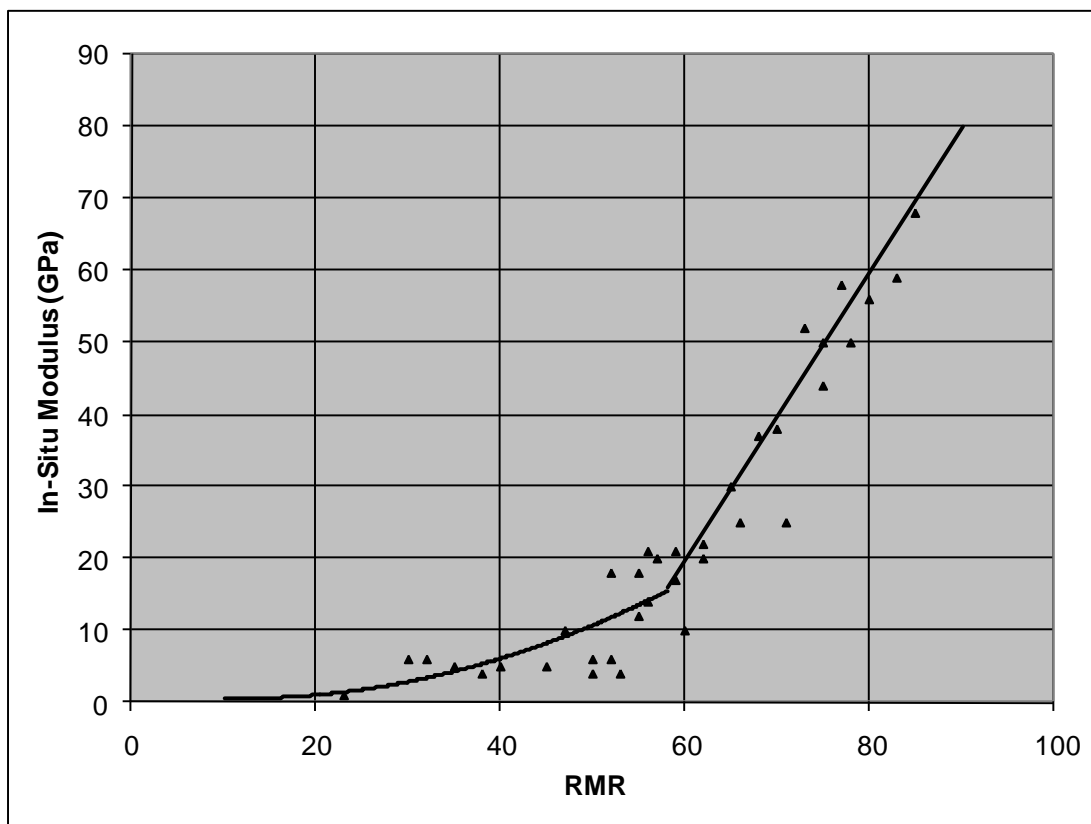
The easiest way to estimate rock mass modulus for a concrete dam foundation involves the use of empirical correlations developed from large scale in-situ jacking test results and rock mechanics index properties. One such relationship is shown in Figure D-7-11, which correlates in situ modulus with Rock Mass Rating (RMR) developed by Bieniawski. RMR is a rock mass quality index that rates the rock mass according to (1) the intact rock strength (typically from lab testing or point load testing), (2) rock quality designation (RQD), (3) joint spacing, and (4) the condition of the joints (continuity, weathering, infilling, roughness) (see Scott(1999) for further details). A separate evaluation would be required for each major rock unit within the foundation of the dam and the effects on dam response evaluated.

Figure D-7-11 Correlation between Rock Mass Modulus and RMR (adapted from Bieniawski, 1989)

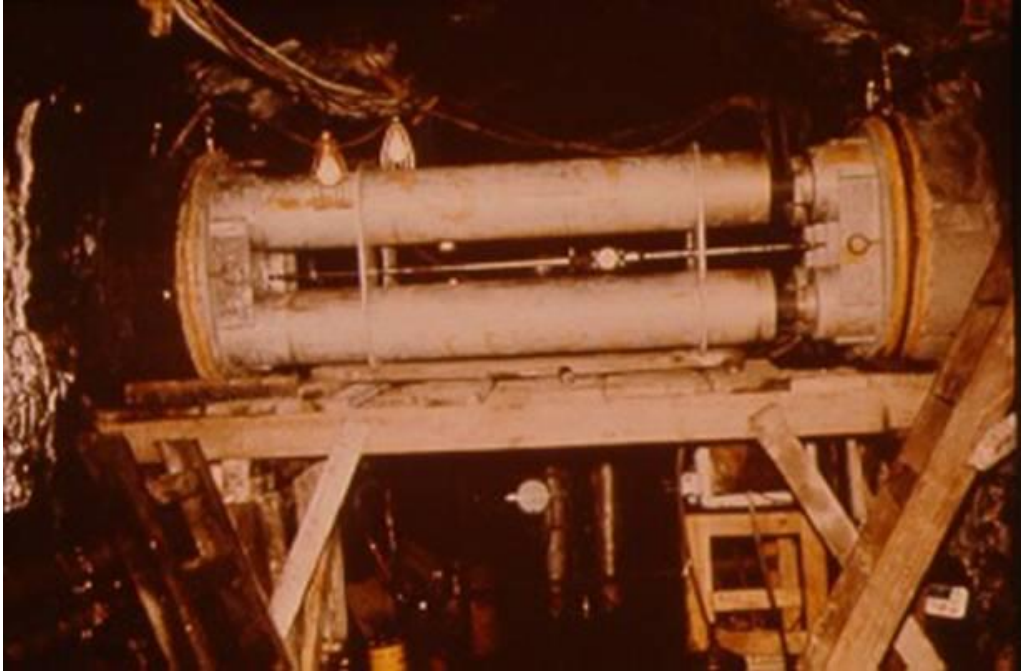
The most direct way to estimate foundation rock mass modulus is to measure it using large scale jacking tests, such as that shown in Figure D-7-12. Loading is applied to the rock mass through large jacks or flat jacks, typically across an excavated tunnel or adit, and the deformation of the rock mass is measured at the rock surface and at depth beneath the loaded surface using multiple position borehole extensometer. The load and deformation data are then used to back calculate a modulus value for the given loading geometry. Limited equipment and expertise currently exists in the United States to perform this type of testing, and additional development may be needed to use this testing method in the future.

Figure D-7-12 In Situ Uniaxial Jacking Test Setup

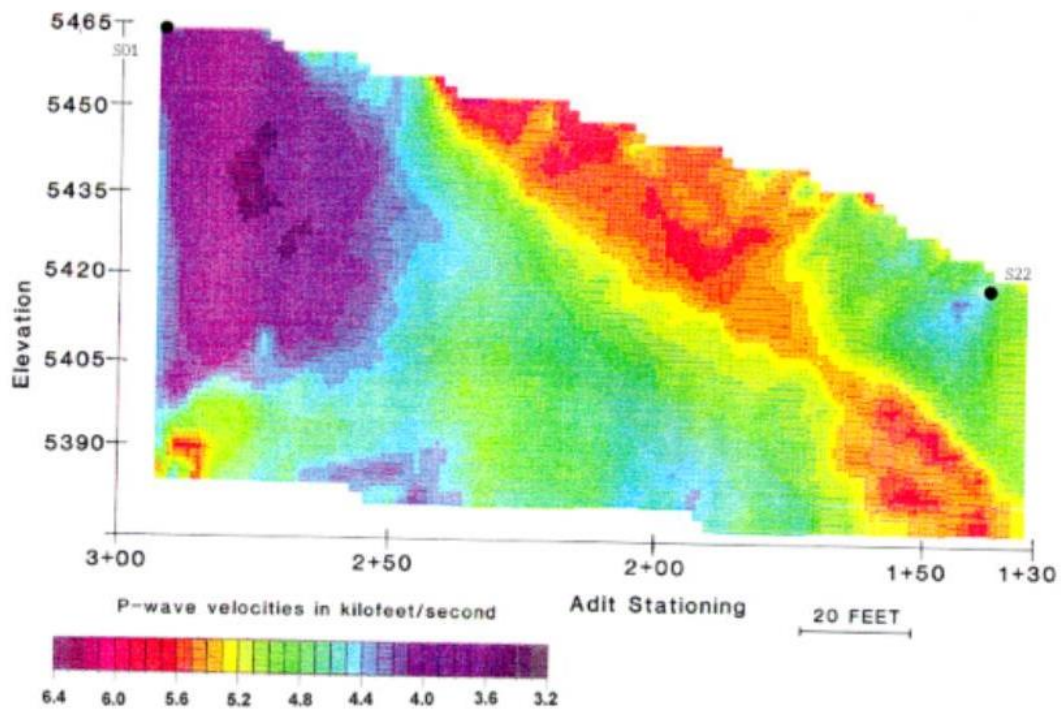
Even though such a jacking test measures a relatively large volume of rock, it is small compared to the volume of a dam foundation. Therefore, a means of relating the jacking test results to the varying geologic conditions within the dam foundation must be established. One such method is seismic tomography. P-wave and/or S-wave velocities are measured over multiple overlapping ray paths between a series of source and receiver locations. The tomographic reconstruction process then gives a picture of the variation in velocity throughout the tested section, similar to a CaT scan. Figure D-7-13 shows a P-wave tomography developed for a dam abutment.

Receivers were placed in the roof of an exploratory adit, and sources were set off along a line on the abutment (ray paths between sources and receivers can also be developed between boreholes). As can be seen, there are zones of relatively large velocity contrast that may be important to the structural response and foundation loading.

Figure A3. Seismic Velocity Tomogram Developed between Ground Surface and Adit.
 Note: 1000 ft/s = 305 m/s.

Figure D-7-13 Seismic Tomograph developed between Adit and Ground Surface

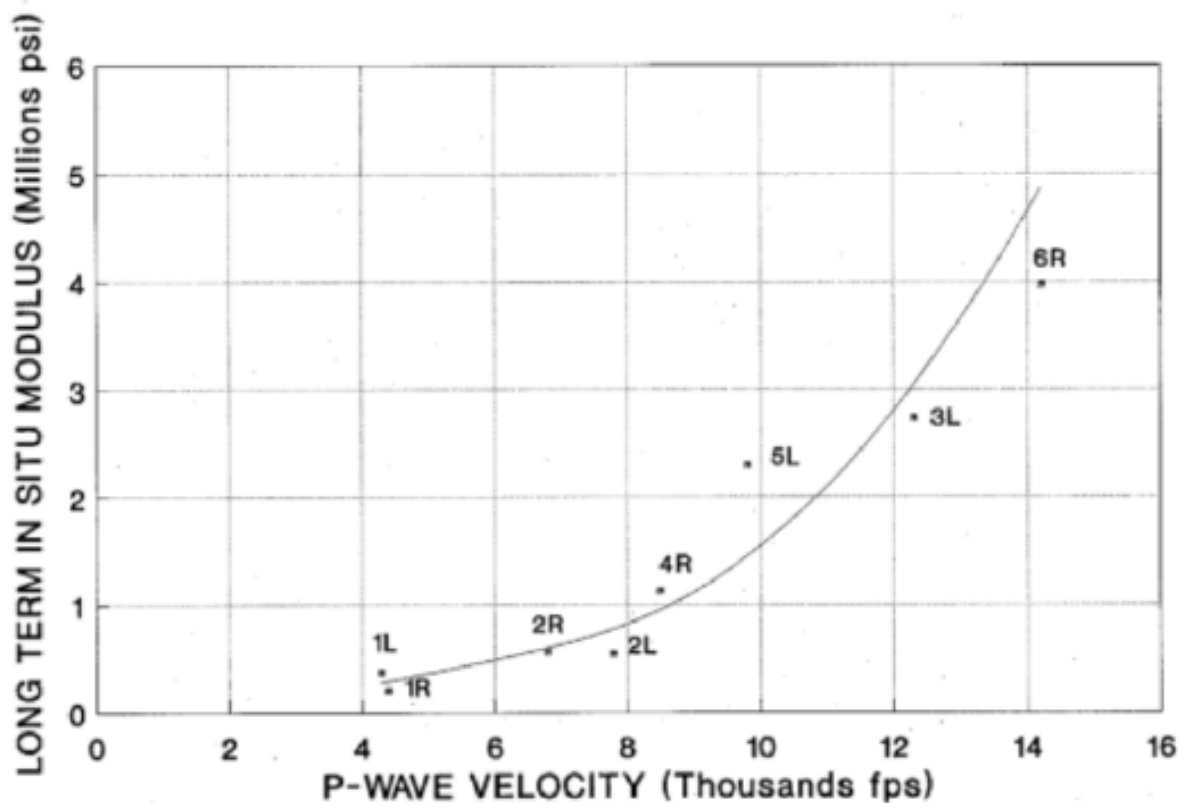
A number of in-situ jacking tests were performed in the exploratory adit to correlate the P-wave velocities with modulus. The correlation was quite good, as shown in Figure D-7-14. Using this relationship, modulus values could be assigned to various velocity zones within the foundation, based on the seismic tomograms.

Figure D-7-14 Correlation of P-wave Velocity with In Situ Modulus

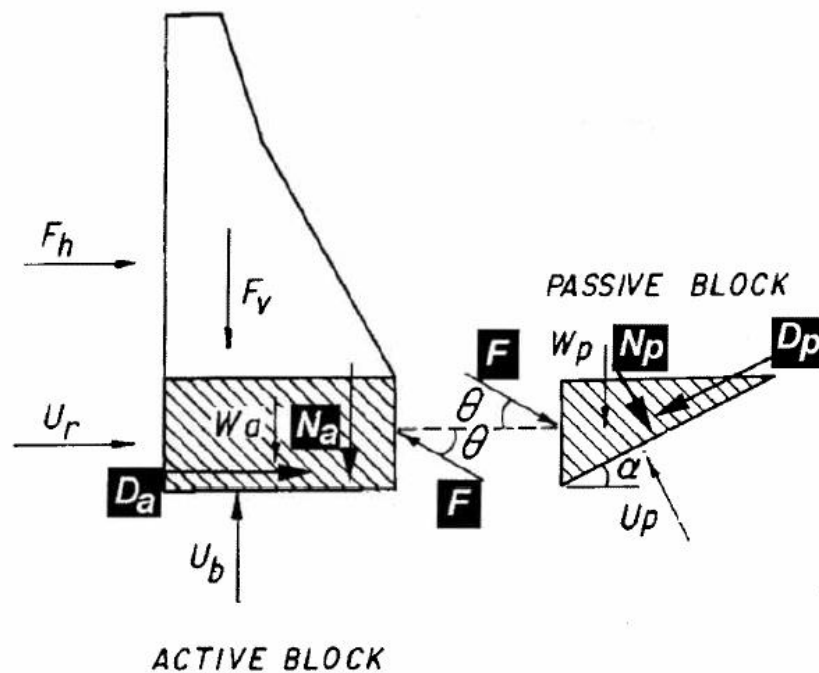
Figure D-7-15 shows a two-wedge sliding analysis typically performed for concrete gravity dams, especially when founded on horizontally bedded sedimentary rock. The traditional 2-D analysis usually involves a passive wedge downstream of the dam. Although this type of analysis can be found in many guidance documents, it can be misused. For one thing, unless the passive wedge is very thin, the intact rock material is very weak, or there is an adversely oriented discontinuity or joint set passing through the passive wedge, it is unlikely that shearing will occur through the passive rock mass. In addition, in order for the passive wedge to move, shearing must occur along the boundary between the active and passive wedge. Unless there is a near vertical joint or discontinuity in this location, this may be unlikely. Finally, the calculated factor of safety is typically sensitive to the inclination angle assumed for the interwedge force, F . At the limit of equilibrium this should approach the friction angle of the interwedge plane. It is usually taken as horizontal which may be conservative in many cases.

Figure D-7-15 Typical Two Wedge Sliding Analysis

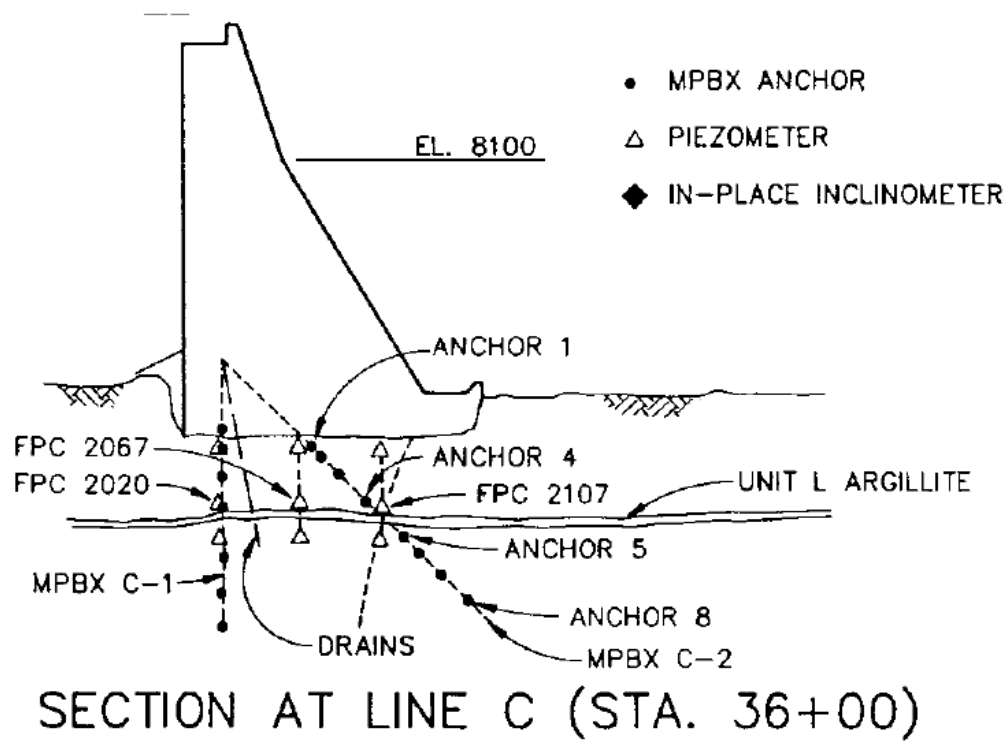
Some deformation is typically needed to mobilize the passive wedge. If there are deformable discontinuities in the rock mass downstream, that deformation may lead to cracking of the concrete. Consider the roller-compacted concrete (RCC) gravity dam shown in Figure D-7-16. The dam is founded on a Cambrian quartzose sandstone foundation. In the abutments and beneath the main dam, interbeds of gray argillite, a lower strength material in between shale and slate, are present. Figure D-7-16 shows a typical instrumentation layout at Line C in the spillway area. Note that there is a weak layer, the Unit L argillite, within the otherwise hard quartzose sandstone. A passive wedge is present downstream of the dam above the Unit L layer. Of note are the vertical and angled MPBX's passing from the gallery through the dam and into the foundation, with anchors above and below the Unit L layer. Piezometers are also installed above and below the Unit L layer, and upstream and downstream of the line of drains. Not shown are the vertical inclinometers passing through the dam and into the foundation through the Unit L layer at sections outside the spillway.

Figure D-7-16 Instrumentation and Geologic Section

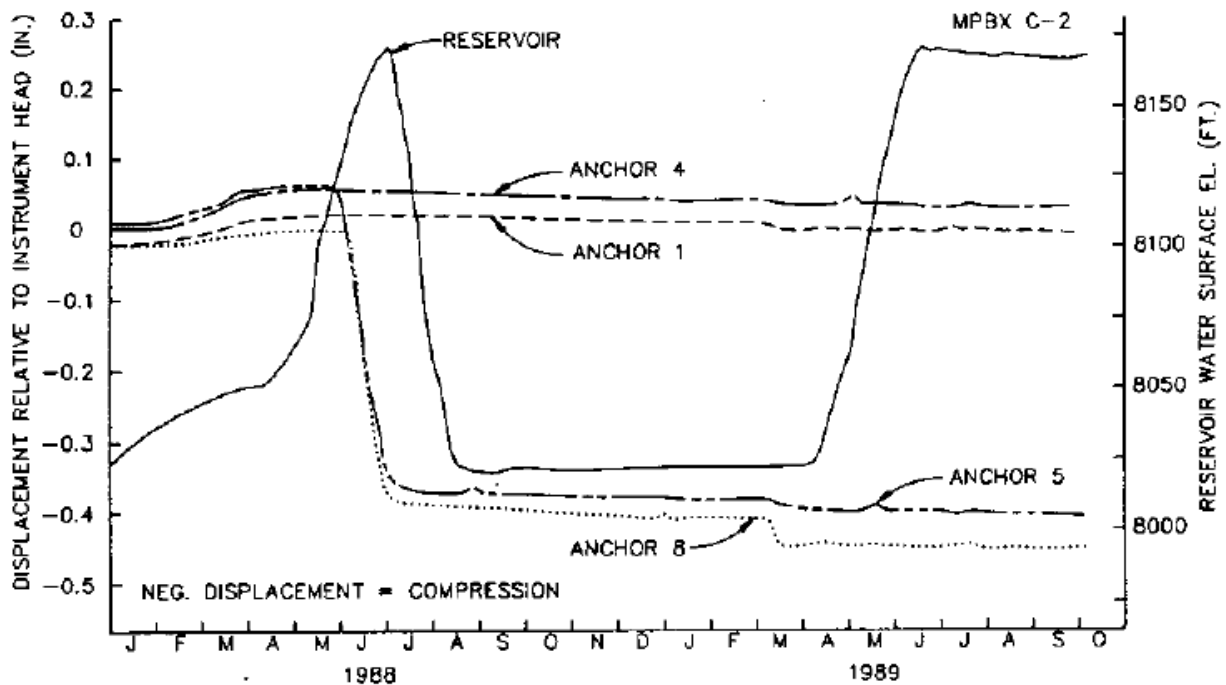
Figure D-7-17 shows the response of the angled MBPX at line C during the first reservoir filling. As the reservoir went up, the anchors below the Unit L argillite layer began to deviate while those above did not. This meant that there was relative movement between the lower anchors and the anchor head, but not between the upper anchors and the anchor head. This suggested that the wedge above the Unit L was moving with respect to the rock below the Unit L. In addition, an inclinometer at a nearby location showed a distinct offset in its profile across the Unit L argillite layer. The piezometers showed relatively high pressures in the upstream and middle area of the foundation.

Figure D-7-17 Angled MPBX Response

Although movement was indicated, the decision was made to continue filling since it was concluded that failure was not in progress and the passive wedge was stable. This conclusion was reached because movement was occurring at a constant rate with increasing reservoir, and movement magnitude and direction was non-uniform across the site. Nevertheless, instrument readings were taken twice a day and sent to the designers for review. If there was any indication of accelerating movements, the designers were given the authority to stop the filling and start drawing down the reservoir. This never occurred, and the movement abruptly stopped when the reservoir filling stopped. The downstream passive resistance was being mobilized through closing of joints in the rock mass which allowed enough deformation to open existing thermally induced cracks. But since there was not an upstream dipping discontinuity, the movement stopped once the passive wedge was mobilized. It should be noted that the foundation movement was enough to open some thermally-induced cracks in the RCC to the point that remedial repairs were required.

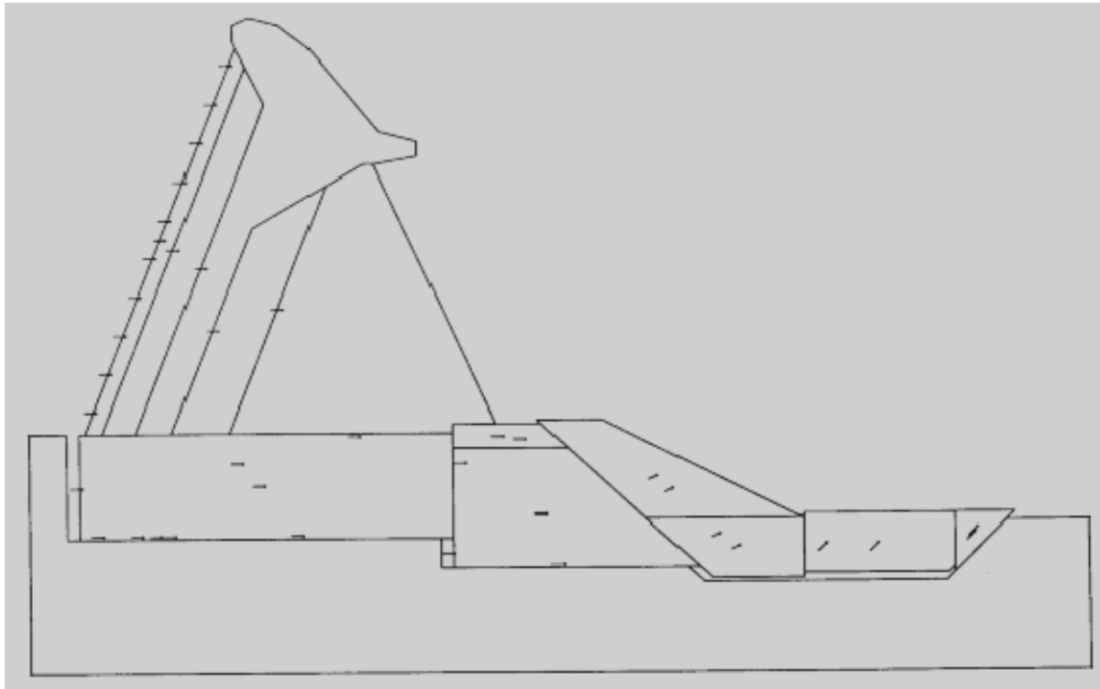
A better approach to performing analysis of multi-wedge systems is to use a distinct element code such as Universal Distinct Element Code (UDEC) or a Discontinuous Deformation Analysis code (DDA), as shown in Figure D-7-18. This type of analysis accounts for the interwedge forces and angles more appropriately. But again, the failure planes must be realistically possible.

Figure D-7-18 DDA Analysis of Multi-Wedge System

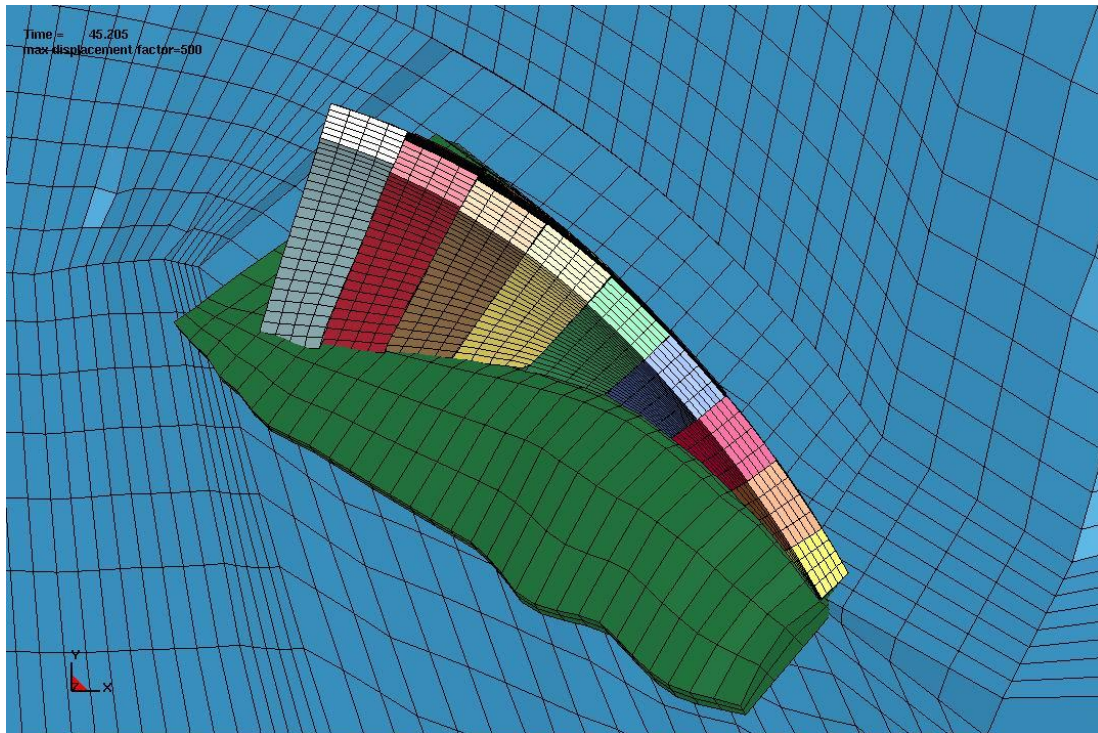
Figure D-7-19 Nonlinear Coupled Dam-Foundation Analysis

An uncoupled evaluation of foundation wedges with external dam loading is typically performed using stereographic vector analysis or rigid block analysis techniques. If these types of analyses indicate high risks, or large dynamic foundation wedge displacements, it may be useful to perform a nonlinear coupled analysis whereby the dam and foundation wedge are included in the same model, as shown in Figure D-7-19. This allows for stress redistribution and allows interaction between the dam and foundation. In addition, if the dam is very thick and it is thought that the potential for foundation wedge movement might be controlled by contraction joints within the dam, this type of analysis can be helpful in demonstrating this type of behavior. However, these types of analyses are complicated, time consuming and expensive, and mistakes
